Validation of Rehabilitation Strategies
to Extend the Service Life of Concrete
Bridge Decks

Extending the Service Life of Concrete Bridge Decks

Testing rehabilitation techniques to maintain highway bridge decks

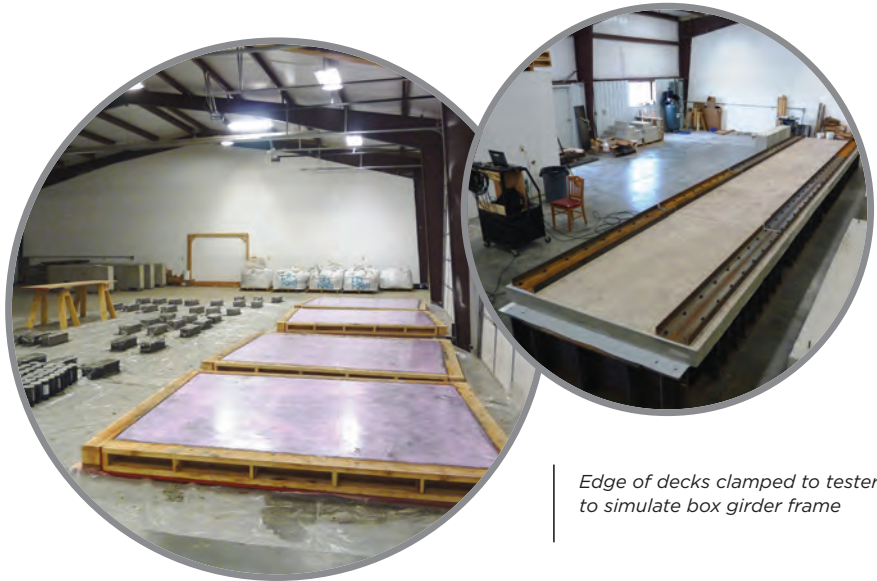
Edge of decks clamped to tester to simulate box girder frame

Full-scale decks cast to Caltrans specifications

To research the effectiveness of methacrylate overlays on top of cracked decks without removing the cover concrete, Caltrans, in partnership with the Montana State University Western Transportation Institute, engineered and assembled a simulator to test concrete decks built to Caltrans specifications. Eight full-sized deck panels (four sets) were cast and fixed to a support structure to model a box girder configuration, the design used for many California bridges. The researchers used an automated, 20-kip rolling wheel load simulator to replicate actual traffic loads on the panels (up to 2,000,000 load cycles). They applied HMWM to three panel sets at different traffic levels—simulating various stages of bridge deck deterioration—to determine whether treatments have an increased effectiveness based on time of application. One panel set was used as an untreated control.

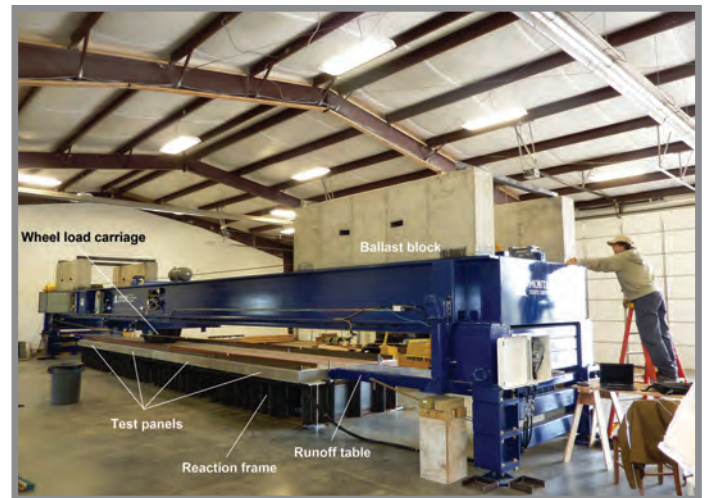
Testing being performed with a 20,000 pound rolling load

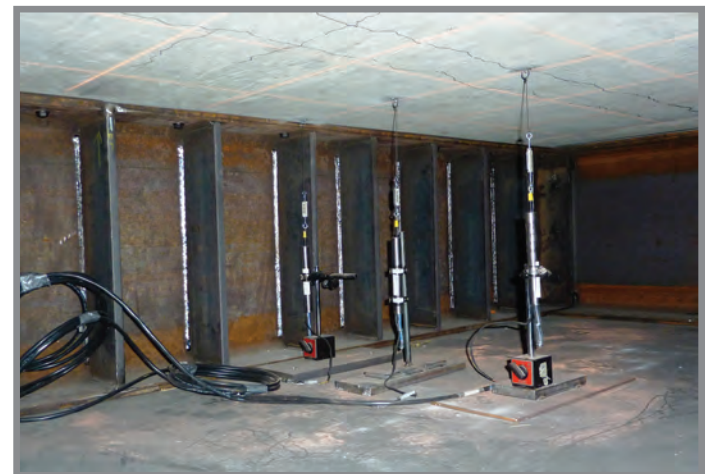
LCPE Instruments recording deflection
